# Manhole Inspection Summary

Manhole # S37QQ\_011MH

Insp Date: **1/16/07 9:22 AM**

**Location** Address: **424 25TH ST**

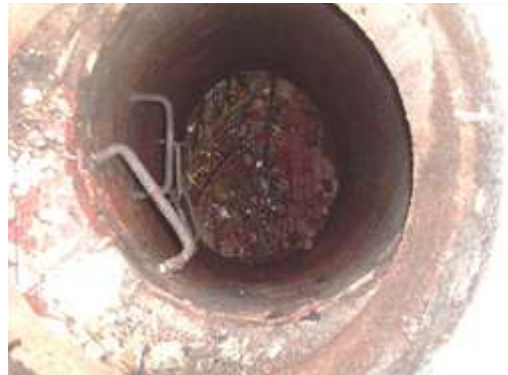
Top View

Channel debris.

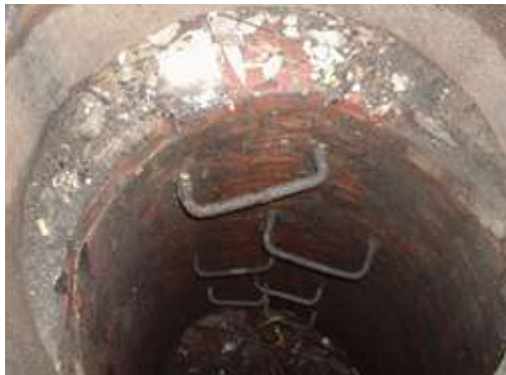
Defect

**Frame** Offset: **8** (in.)

☒ **Leaks**

Condition: ☐ Sound ☐ Cracked ☐ Root Intrusion ☐ Loose Brick ☒ **Deteriorated**

Infiltration: ☐ None ☒ **Joint** ☐ Cracks ☐ Mortar ☐ Roots ☒ **Wall**

Frame leaks. Frame offset. Adjustment deterioration and infiltration.

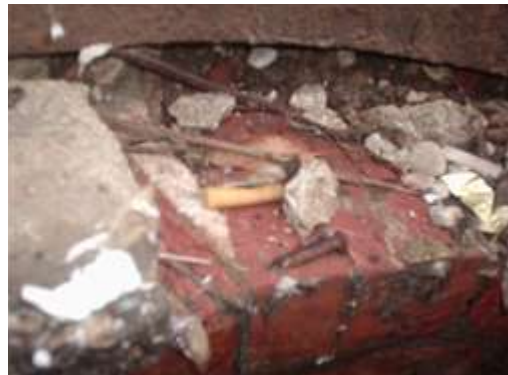
Defect

Frame leaks. Frame offset. Adjustment deterioration and infiltration.

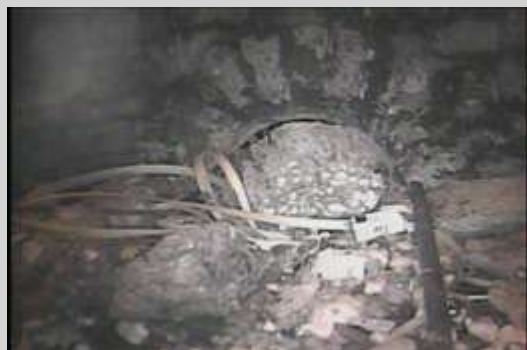
Pipe Out @ 12 O'Clock

Deposits: ☐ None ☒ **Mud** ☐ Sludge ☒ **Debris** ☐ Grease

Silt Depth: **8** (in.)

Deposits Extent: **Heavy**
